2020 Update to the Site Discharge Pollution Prevention Plan, Revision 1

NPDES Permit No. NM0030759

May 1, 2021

Sandia/Mortandad Watershed

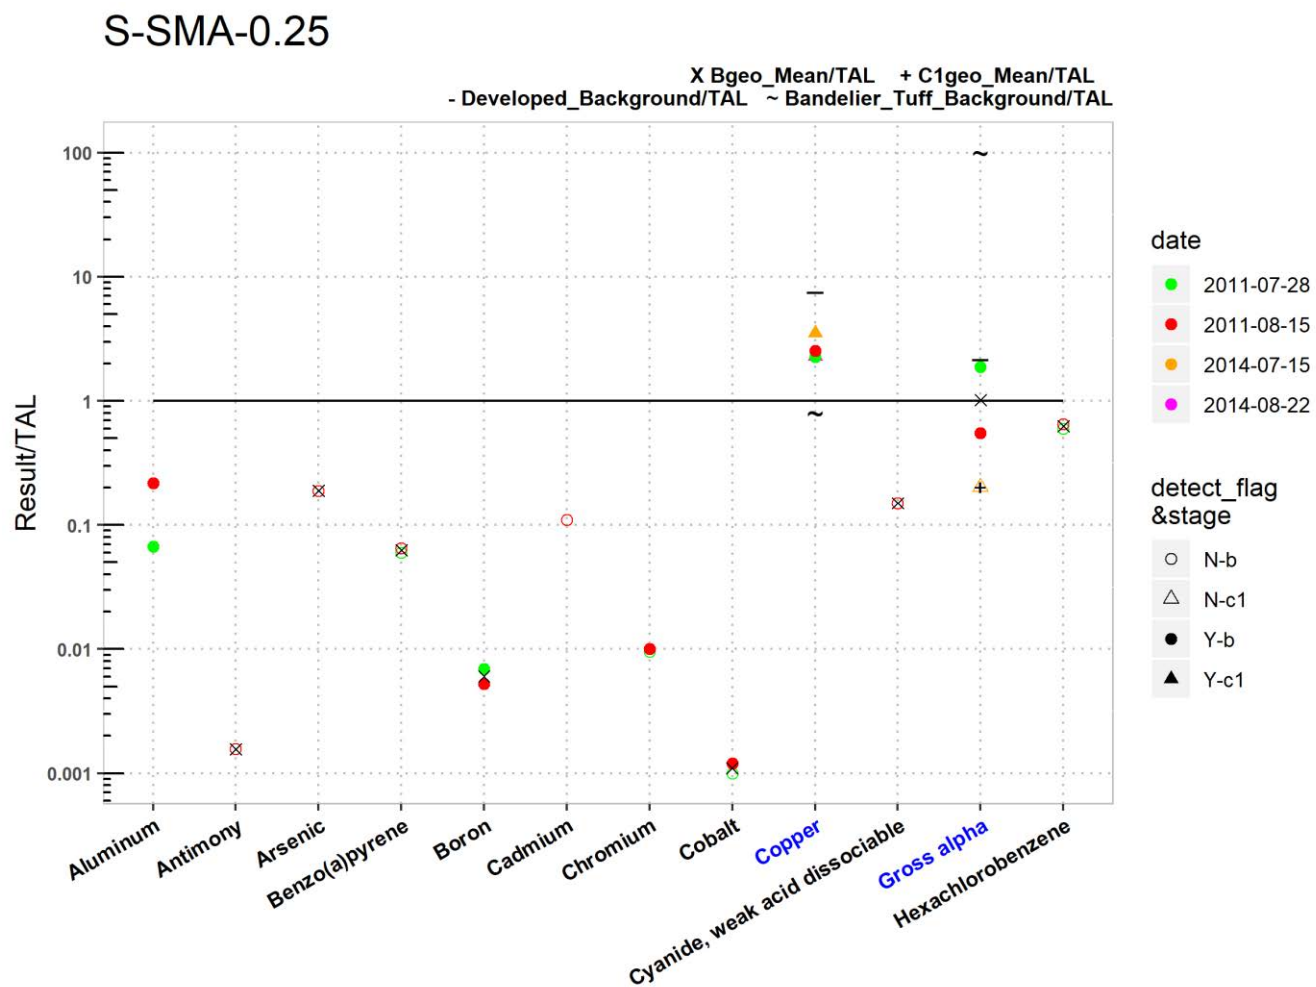
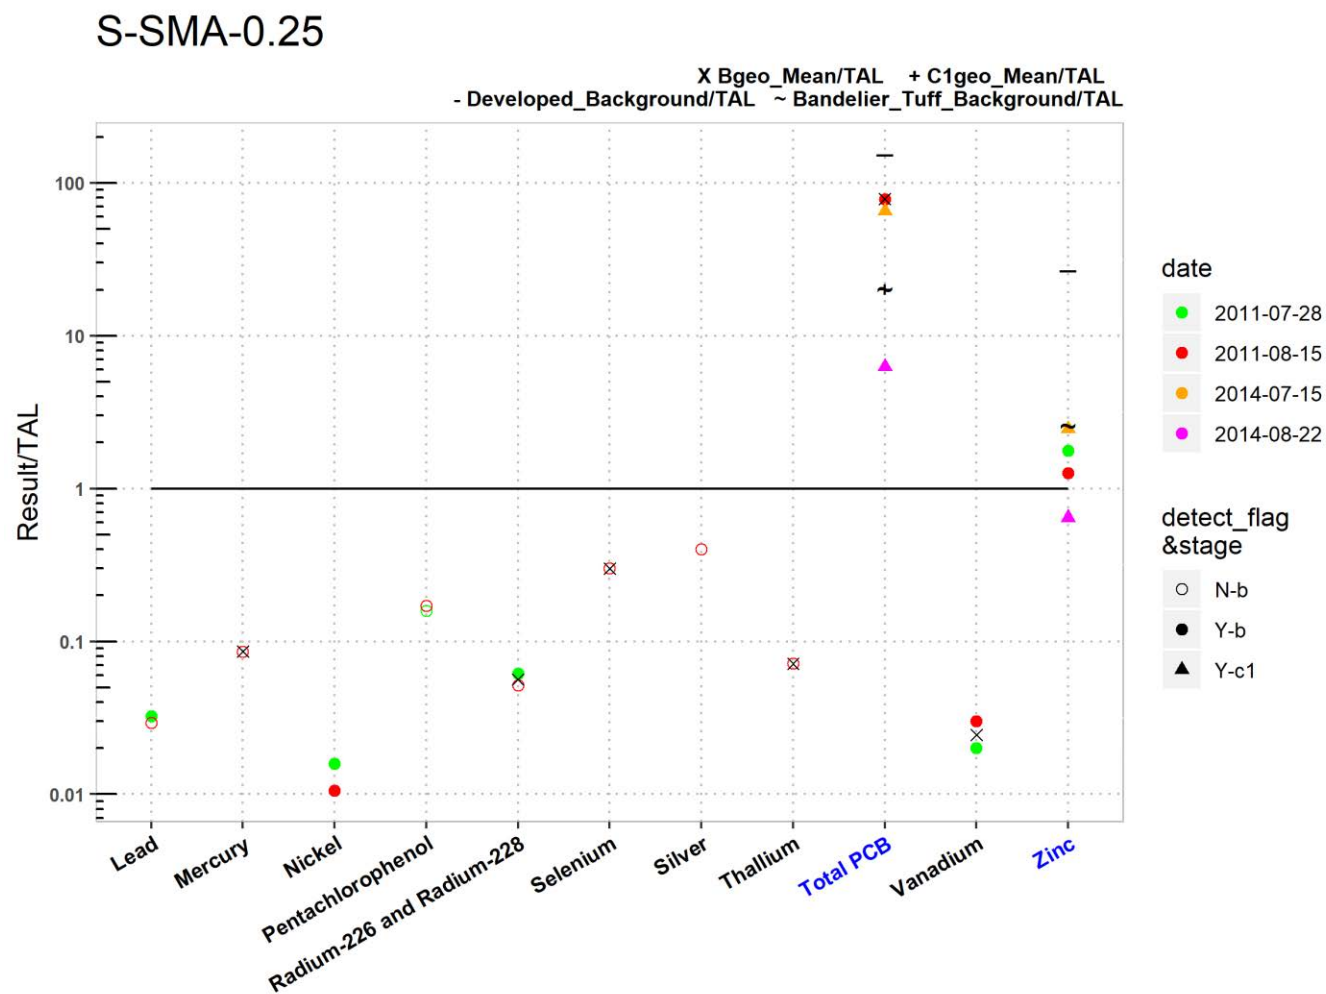
Figure 65-2 Analytical results summary for S-SMA-0.25

SWMUs 03-013(a) and 03-052(f) are monitored within S-SMA-0.25. Following the installation of baseline control measures, baseline storm water samples were collected on July 28, 2011, and August 15, 2011 (Figure 65-2). Analytical results from these samples yielded TAL exceedances for copper (9.7 µg/L and 10.9 µg/L), gross-alpha activity (28.1 pCi/L), PCB concentration (50 ng/L), and zinc (52.9 µg/L and 74.4 µg/L) and are presented in Figure 65-2.

Following the installation of enhanced control measures at S-SMA-0.25, corrective action storm water samples were collected on July 15, 2014, and August 22, 2014 (Figure 65-2). Analytical results from these corrective action monitoring samples yielded TAL exceedances for copper (15.2 µg/L and 9.79 µg/L), PCB concentrations (42 ng/L and 4 ng/L), and zinc (103 µg/L) and are presented in Figure 65-2.

The SMA sampler receives runoff from a large storm drain system that captures runoff from roof drains, roads, and parking areas from a 33-acre developed area consisting of approximately 50% of TA-03. The concentrations of copper and zinc detected in the SMA samples are less than the developed area background UTLs, consistent with the Site not being the source of these TAL exceedances. The concentration of PCBs detected in the SMA sample is less than the developed background UTL. Although the Site may contribute to the PCBs found in the SMA sample, the likely source of PCBs contributing to the TAL exceedance in the storm water at S-SMA-0.25 is urban “background” PCBs.

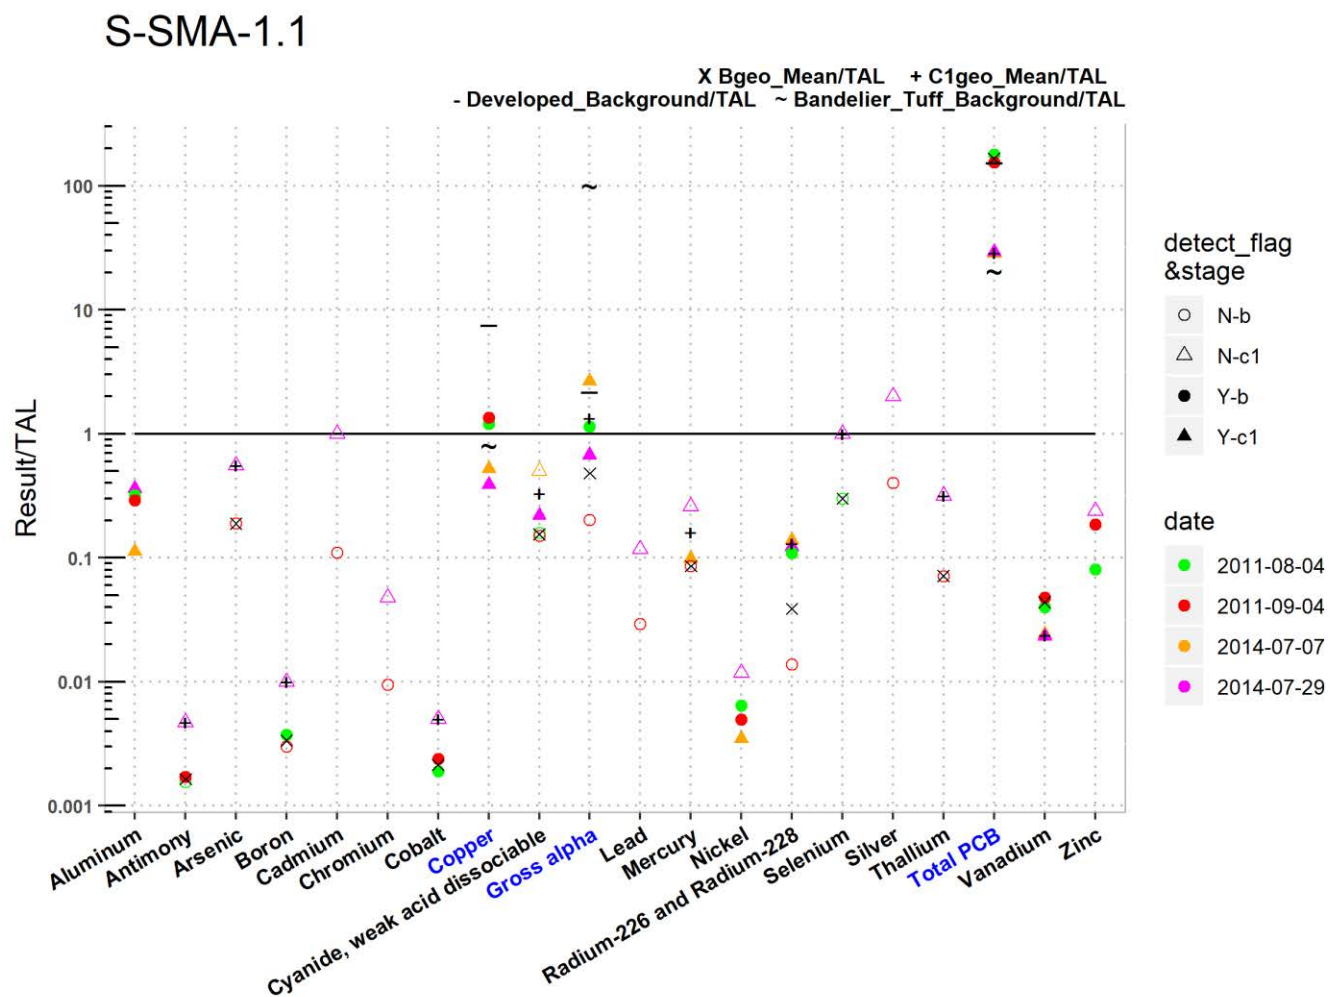
Figure 66-2 Analytical results summary for S-SMA-1.1

SWMU 03-029 is monitored within S-SMA-1.1. Following the installation of baseline control measures, a baseline storm water sample was collected on August 4, 2011, and September 4, 2011 (Figure 66-2). In Figure 66-2, cadmium, selenium, and silver are reported as nondetected results greater than their respective TALs. These values are reported at the PQL, the MDL for these analytes are below the TAL. The values are nondetects and thus not considered TAL exceedances. Analytical results from these samples yielded TAL exceedances for copper (5.2 µg/L and 5.8 µg/L), gross-alpha activity (17.1 pCi/L), and PCB concentrations (90 ng/L and 110 ng/L) and are presented in Figure 66-2.

Following the installation of enhanced control measures at S-SMA-1.1, corrective action storm water samples were collected on July 7, 2014, and July 29, 2014 (Figure 66-2). Analytical results from these corrective action monitoring samples yielded TAL exceedances for gross-alpha activity (39.9 pCi/L) and PCB concentrations (18 ng/L and 19 ng/L) and are presented in Figure 66-2.

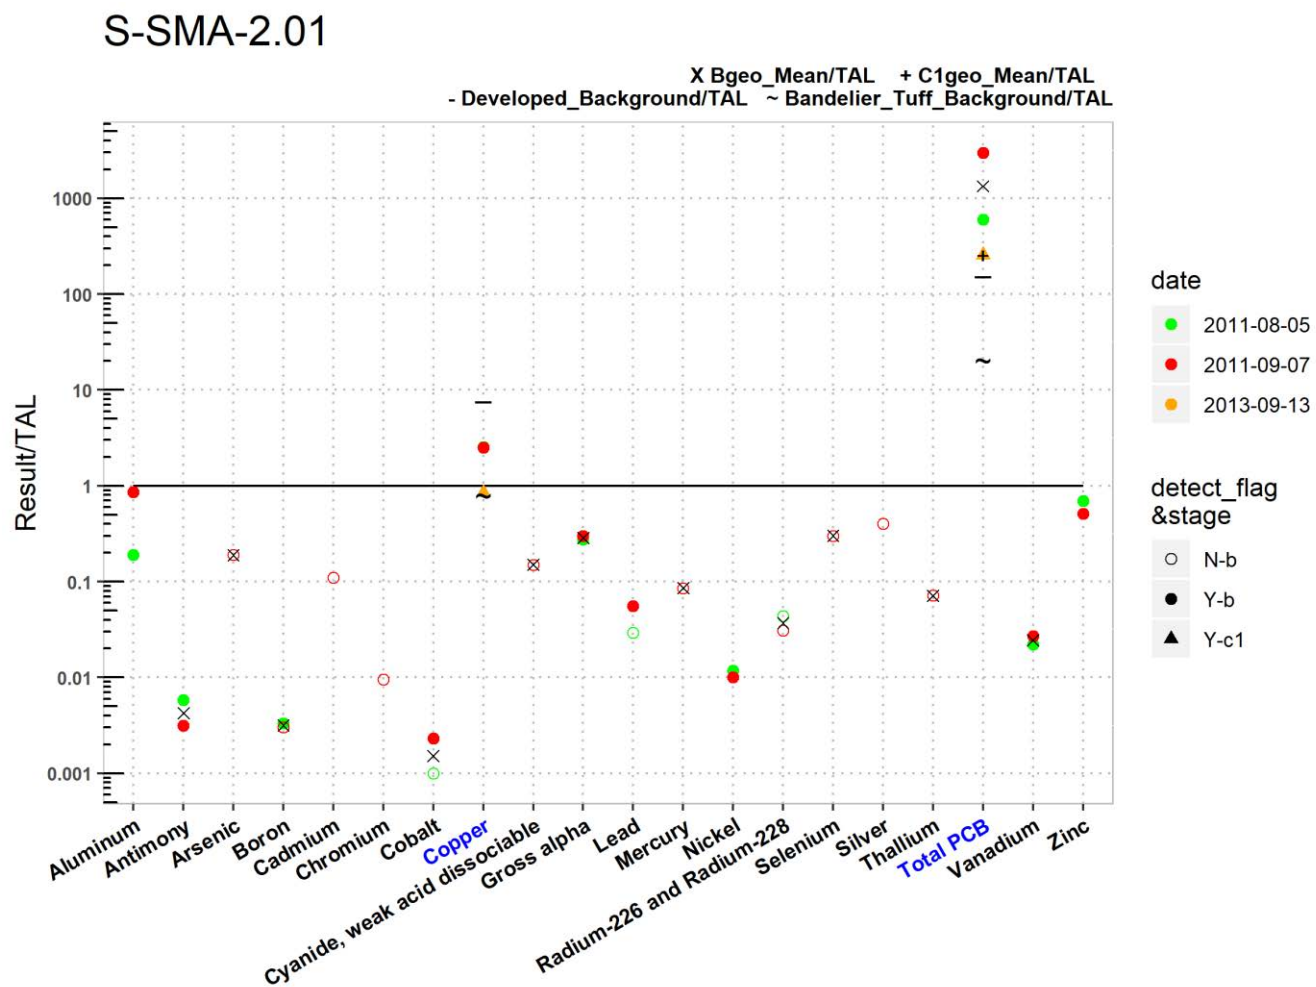
Figure 68-2 Analytical results summary for S-SMA-2.01

Monitoring location S-SMA-2.01 receives storm water run-on from developed environments, including paved parking lots, roads, and buildings, as well as from landscape consisting of Bandelier Tuff sediment. Metals including copper are associated with building materials, parking lots, and automobiles as well as low concentrations in the Bandelier Tuff. PCBs are associated with building materials including paint, caulking, asphalt, solvents, transformers, and cutting oils.

- PCBs—The PCB UTL from developed landscape storm water run-on is 98 ng/L; the PCB UTL for storm water containing sediments derived from Bandelier Tuff is 11.7 ng/L. The PCB results from 2011 and 2013 are greater than both of these values.

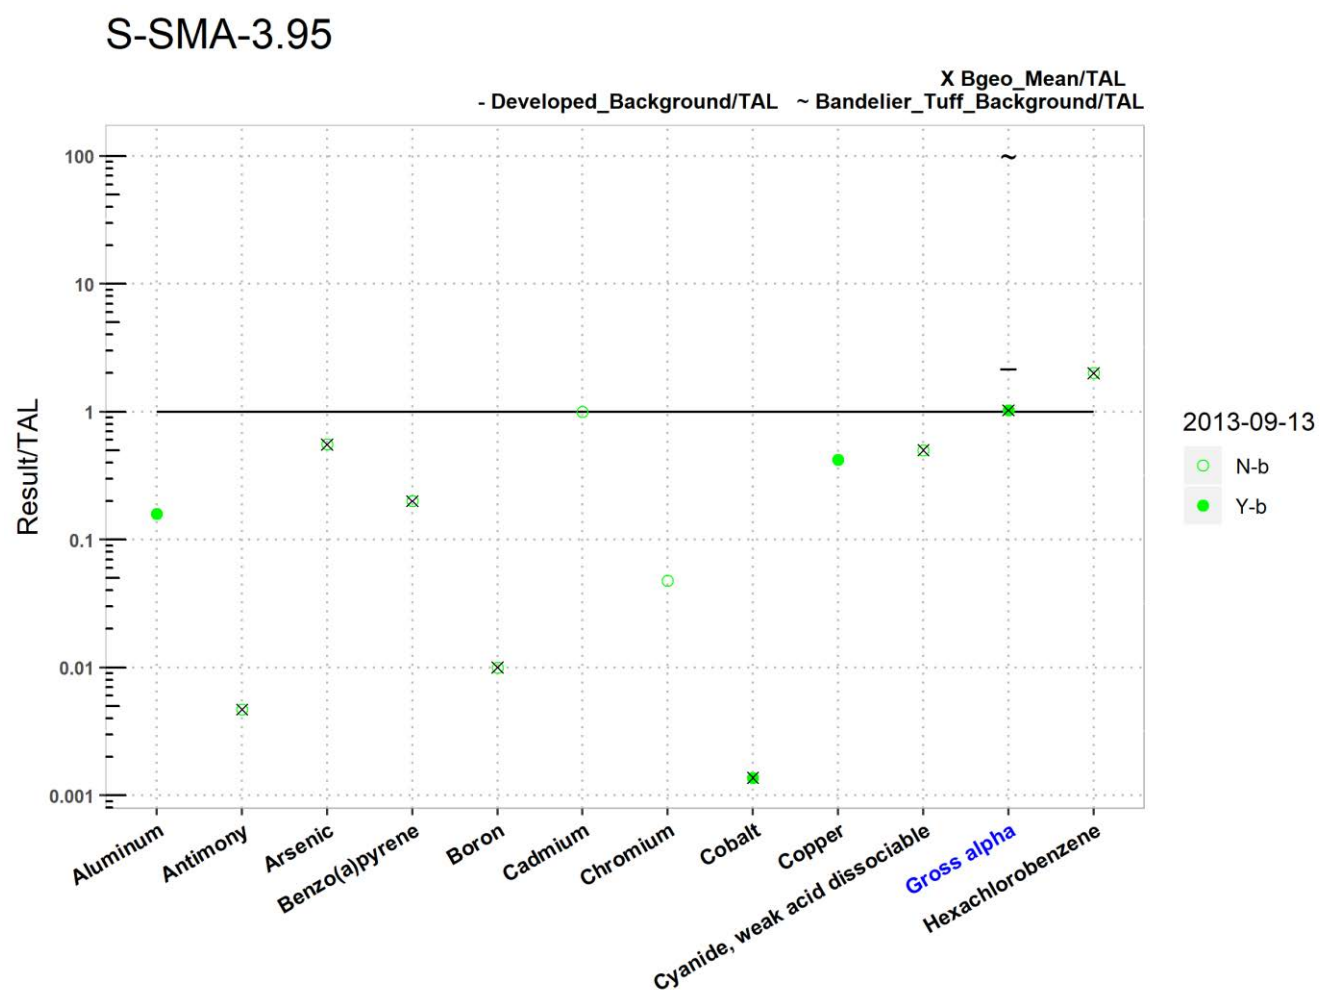
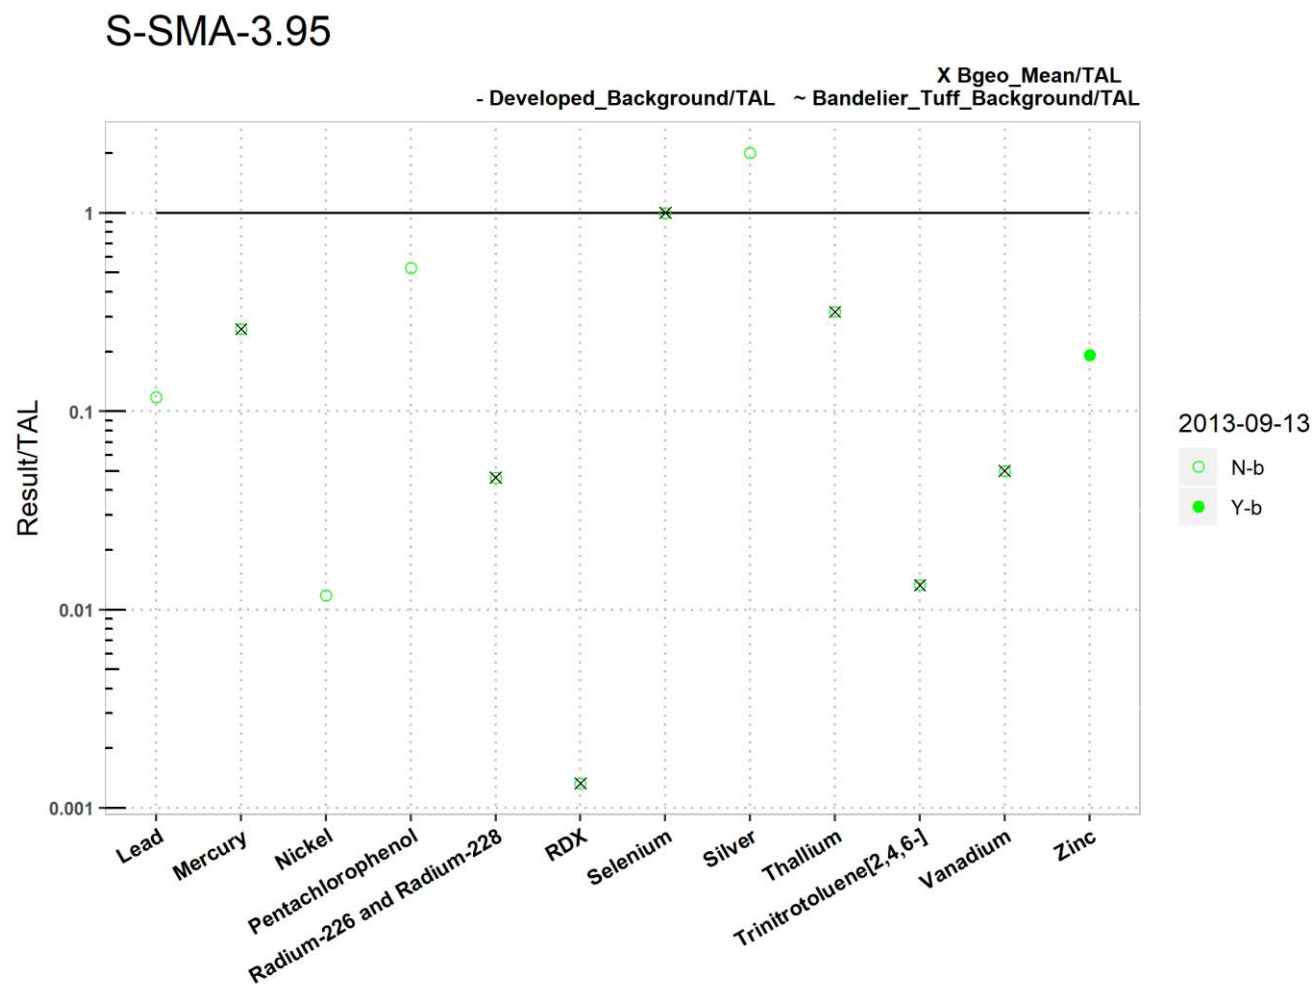
Figure 77-2 Analytical results summary for S-SMA-3.95

SWMU 20-002(a) is monitored within S-SMA-3.95. Following the installation of baseline control measures, a baseline storm water sample was collected on September 13, 2013 (Figure 77-2). In Figure 77-2, cadmium, selenium, silver, and hexachlorobenzene are reported as nondetected results greater than their respective TALs. These values are reported at the PQL, the MDL for these analytes are below the TAL. The values are nondetects and thus not considered TAL exceedances. Analytical results from this sample yielded a TAL exceedance for gross-alpha activity (15.4 pCi/L) and are presented in Figure 77-2.

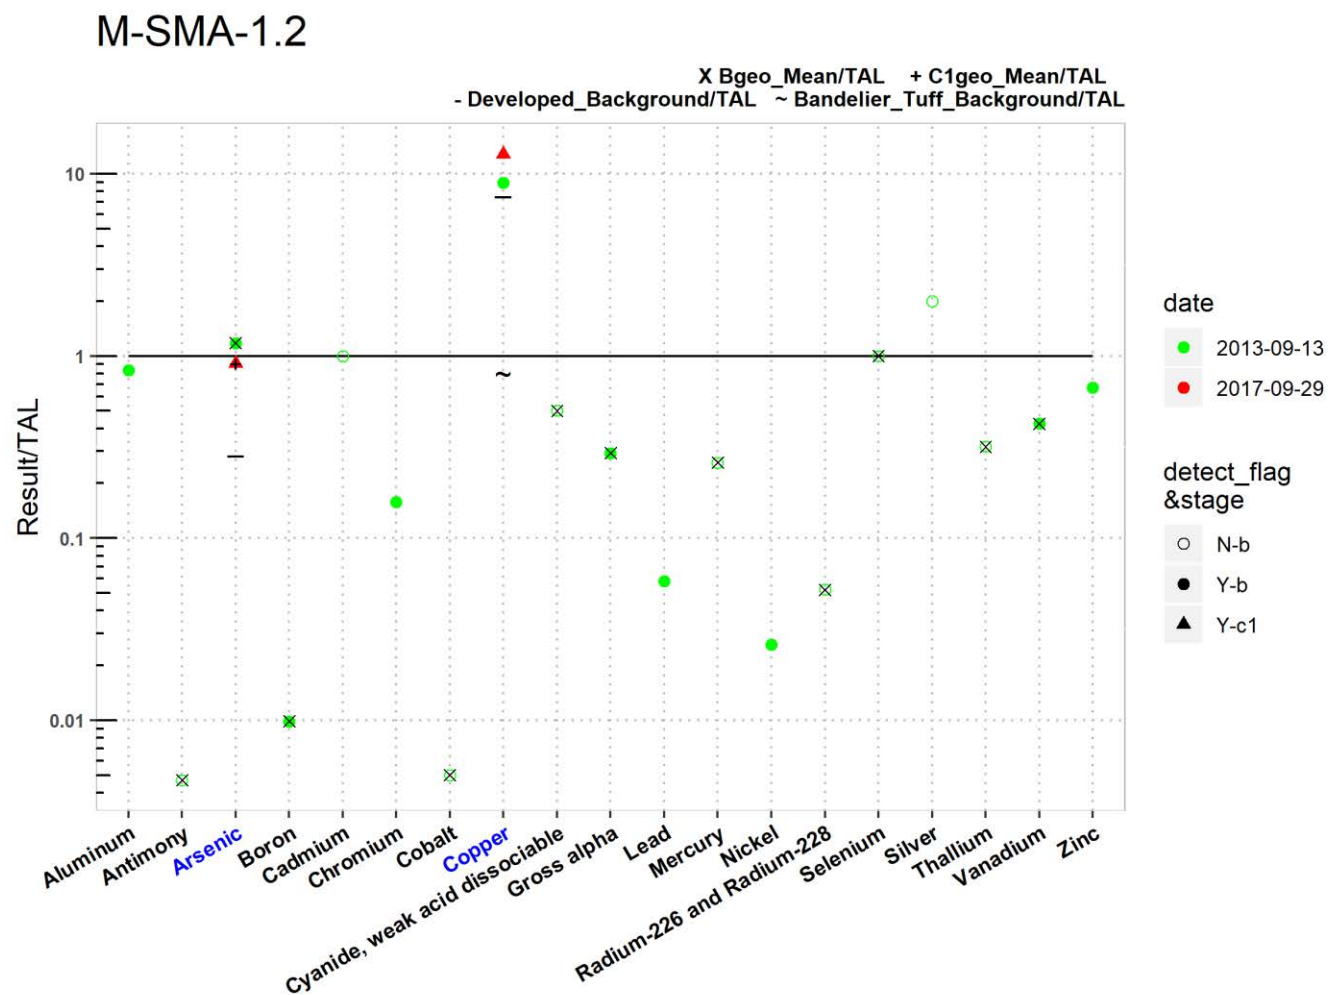
Figure 95-2 Analytical results summary for M-SMA-1.2

SWMU 03-049(a) is monitored within M-SMA-1.2. Following the installation of baseline control measures, a baseline storm water sample was collected on September 13, 2013 (Figure 95-2). In Figure 95-2, cadmium, selenium, and silver are reported as nondetected results greater than their respective TALs. These values are reported at the PQL, the MDL for these analytes are below the TAL. The values are nondetects and thus not considered TAL exceedances. Analytical results from this sample yielded TAL exceedances for arsenic (10.6 µg/L) and copper (38.4 µg/L) and are presented in Figure 95-2.

Following certification of enhanced control measure installation, a corrective action confirmation monitoring storm water sample was collected on September 29, 2017 (Figure 95-2). Analytical results from this sample yielded a TAL exceedance for copper (55 µg/L) and are presented in Figure 95-2.

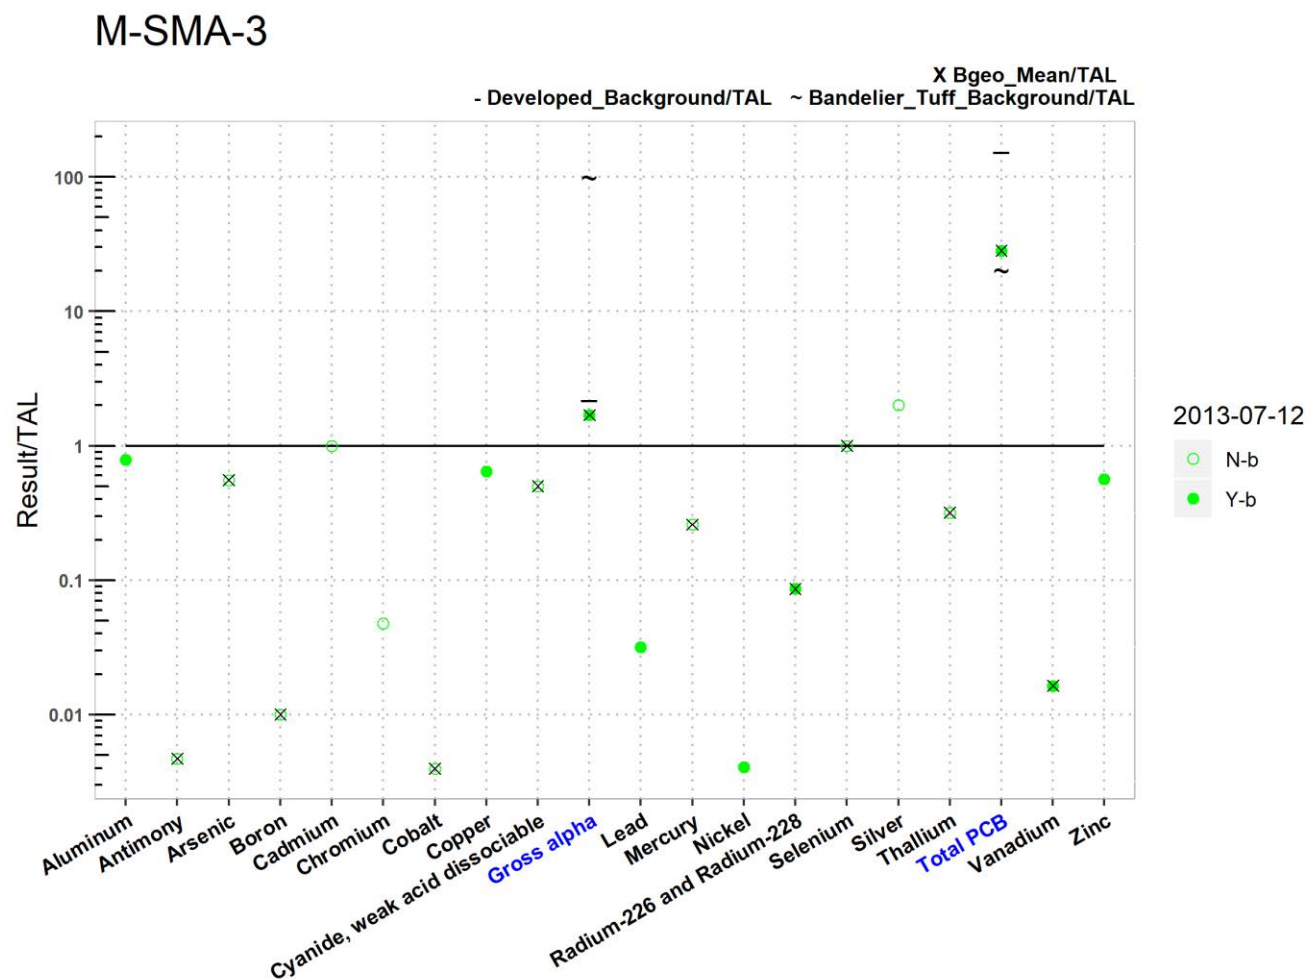
Figure 98-2 Analytical results summary for M-SMA-3

SWMUs 48-005 and 48-007(c) and AOC 48-001 are monitored within M-SMA-3. Following the installation of baseline control measures, a baseline storm water sample was collected on July 12, 2013 (Figure 98-2). In Figure 98-2, cadmium, selenium, and silver are reported as nondetected results greater than their respective TALs. These values are reported at the PQL, the MDL for these analytes are below the TAL. The values are nondetects and thus not considered TAL exceedances. Analytical results from this sample yielded TAL exceedances for gross-alpha activity (25.4 pCi/L) and PCB concentration (18 ng/L) and are presented in Figure 98-2.

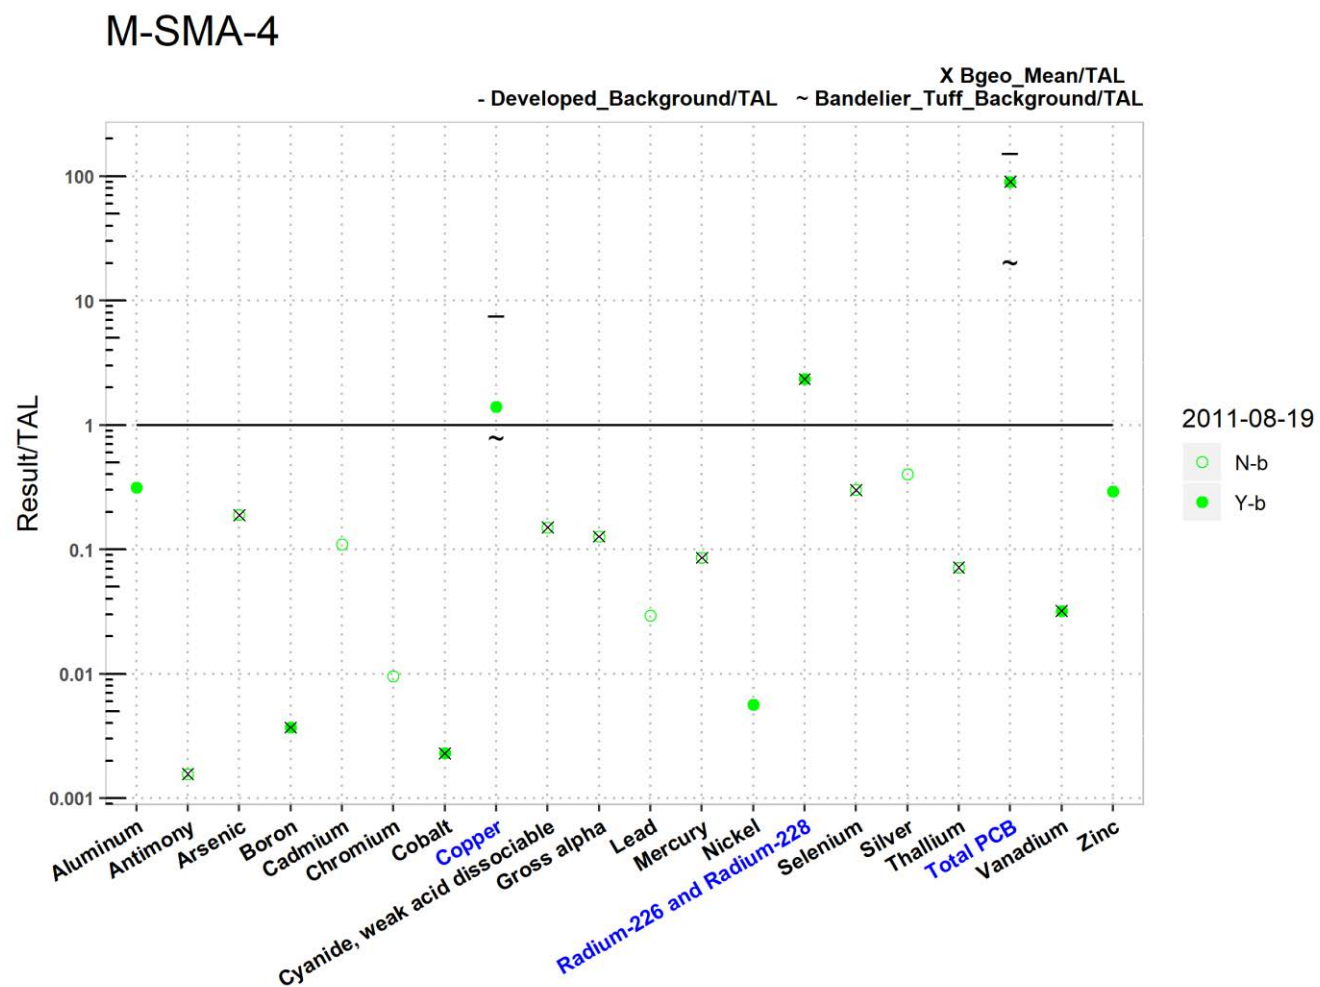
Figure 101-2 Analytical results summary for M-SMA-4

AOC 48-001 and SWMUs 48-005, 48-007(a), 48-007(d), and 48-010 are monitored within M-SMA-4. Following the installation of baseline control measures, a baseline storm water sample was collected on August 19, 2011 (Figure 101-2). Analytical results from this sample yielded TAL exceedances for copper (6 µg/L), radium-226 and radium-228 activity (70.3 pCi/L) and PCB concentration (50 ng/L) and are presented in Figure 101-2.

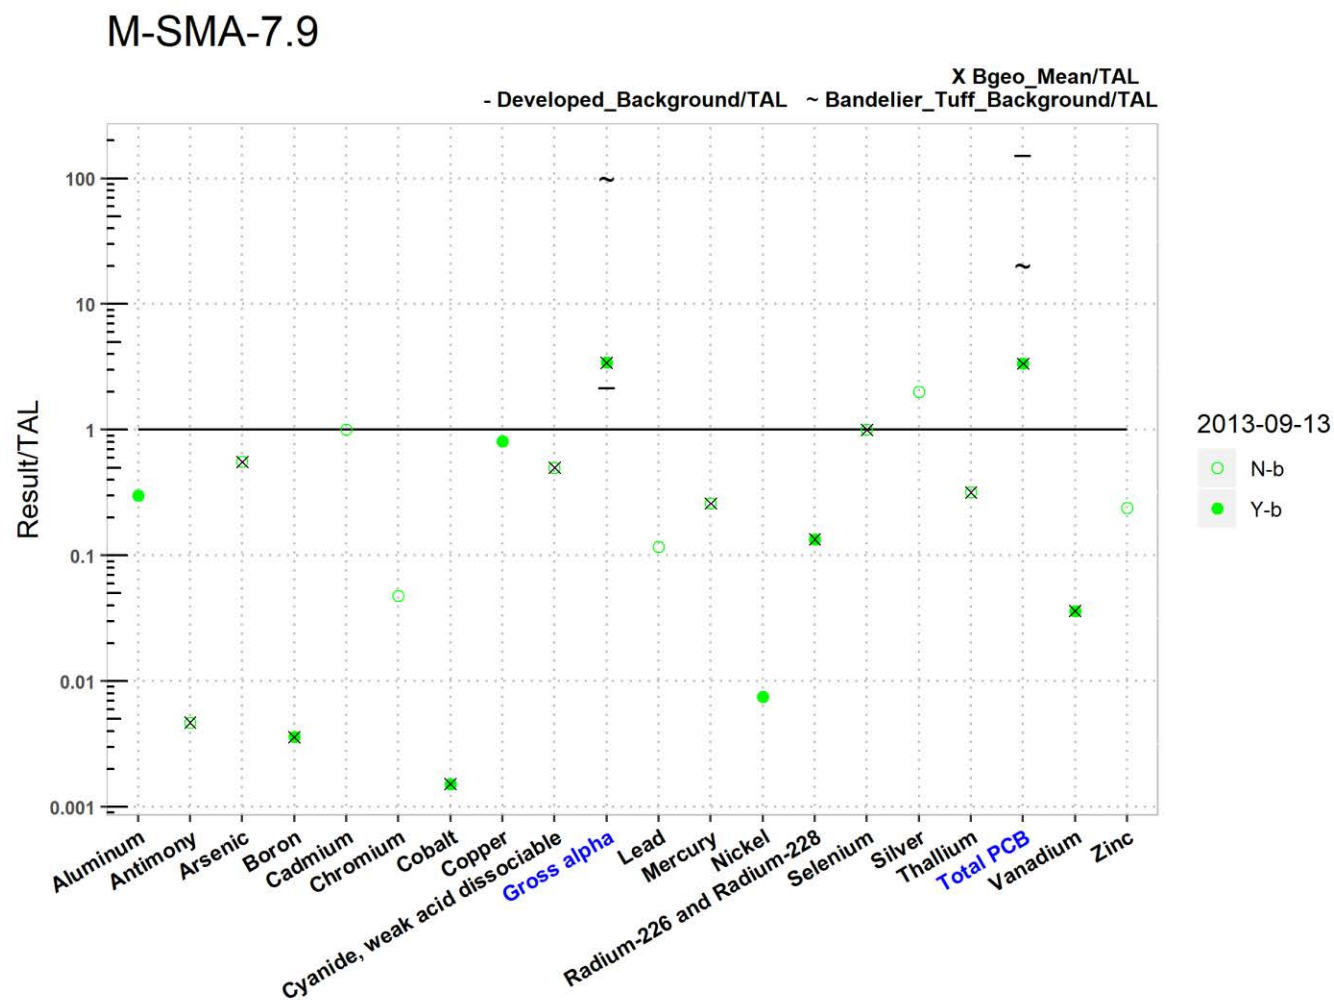
Figure 105-2 Analytical results summary for M-SMA-7.9

SWMU 50-006(d) is monitored within M-SMA-7.9. Following the installation of baseline control measures, a baseline storm water sample was collected on September 13, 2013 (Figure 105-2). In Figure 105-2, cadmium, selenium, and silver are reported as nondetected results greater than their respective TALs. These values are reported at the PQL, the MDL for these analytes are below the TAL. The values are nondetects and thus not considered TAL exceedances. Analytical results from this sample yielded TAL exceedances for gross-alpha activity (51.4 pCi/L) and PCB concentration (2 ng/L) and are presented in Figure 105-2.

TAL exceedances were also evaluated against the appropriate storm water BVs, that is, “Bandelier Tuff background” for undisturbed SMAs or “developed background” for urban settings. BVs are expressed as UTLs using the approved EPA method for calculating BVs. UTLs for undisturbed SMAs were derived from storm water runoff containing entrained sediments derived from Bandelier Tuff and are labeled “Bandelier Tuff Background” in Figure 105-2. UTLs developed for urban settings were derived from runoff from developed landscapes on the Pajarito Plateau, including buildings, parking lots, roads, and associated features, and are labeled “Developed Background” in Figure 105-2.

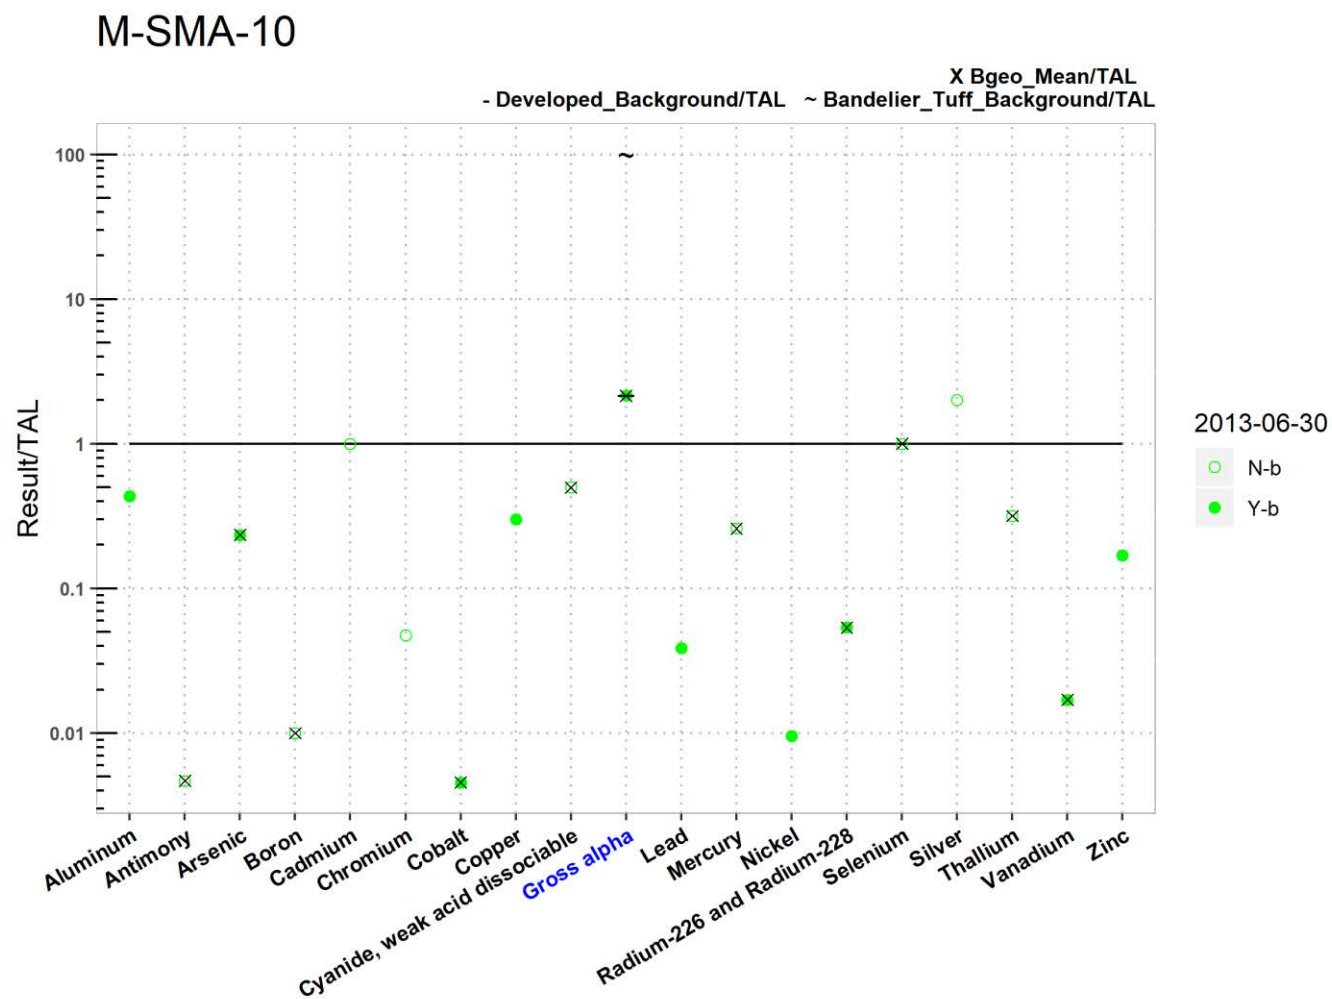
Figure 107-2 Analytical results summary for M-SMA-10

SWMUs 35-008 and 35-014(e) were monitored within M-SMA-10. Following the installation of baseline control measures, a baseline storm water sample was collected on June 30, 2013 (Figure 107-2). In October 2015, NMED issued a COC for SWMUs 35-008 and 35-014(e). These Sites are now certified as corrective action complete, and monitoring of storm water discharges has ceased at M-SMA-10. No further sampling is required for M-SMA-10 for the remainder of the IP. In Figure 107-2, cadmium, selenium, and silver are reported as nondetected results greater than their respective TALs. These values are reported at the PQL; the MDL for these analytes are below the TAL. The values are nondetects and thus not considered TAL exceedances. Analytical results from this sample yielded a TAL exceedance for gross-alpha activity (32.2 pCi/L) and are presented in Figure 107-2.

TAL exceedances were also evaluated against the appropriate storm water BVs, that is, “Bandelier Tuff background” for undisturbed SMAs or “developed background” for urban settings. BVs are expressed as UTLs using the approved EPA method for calculating BVs. UTLs for undisturbed SMAs were derived from storm water runoff containing entrained sediments derived from Bandelier Tuff and are labeled “Bandelier Tuff Background” in Figure 107-2. UTLs developed for urban settings were derived from runoff from developed landscapes on the Pajarito Plateau, including buildings, parking lots, roads, and associated features, and are labeled “Developed Background” in Figure 107-2.

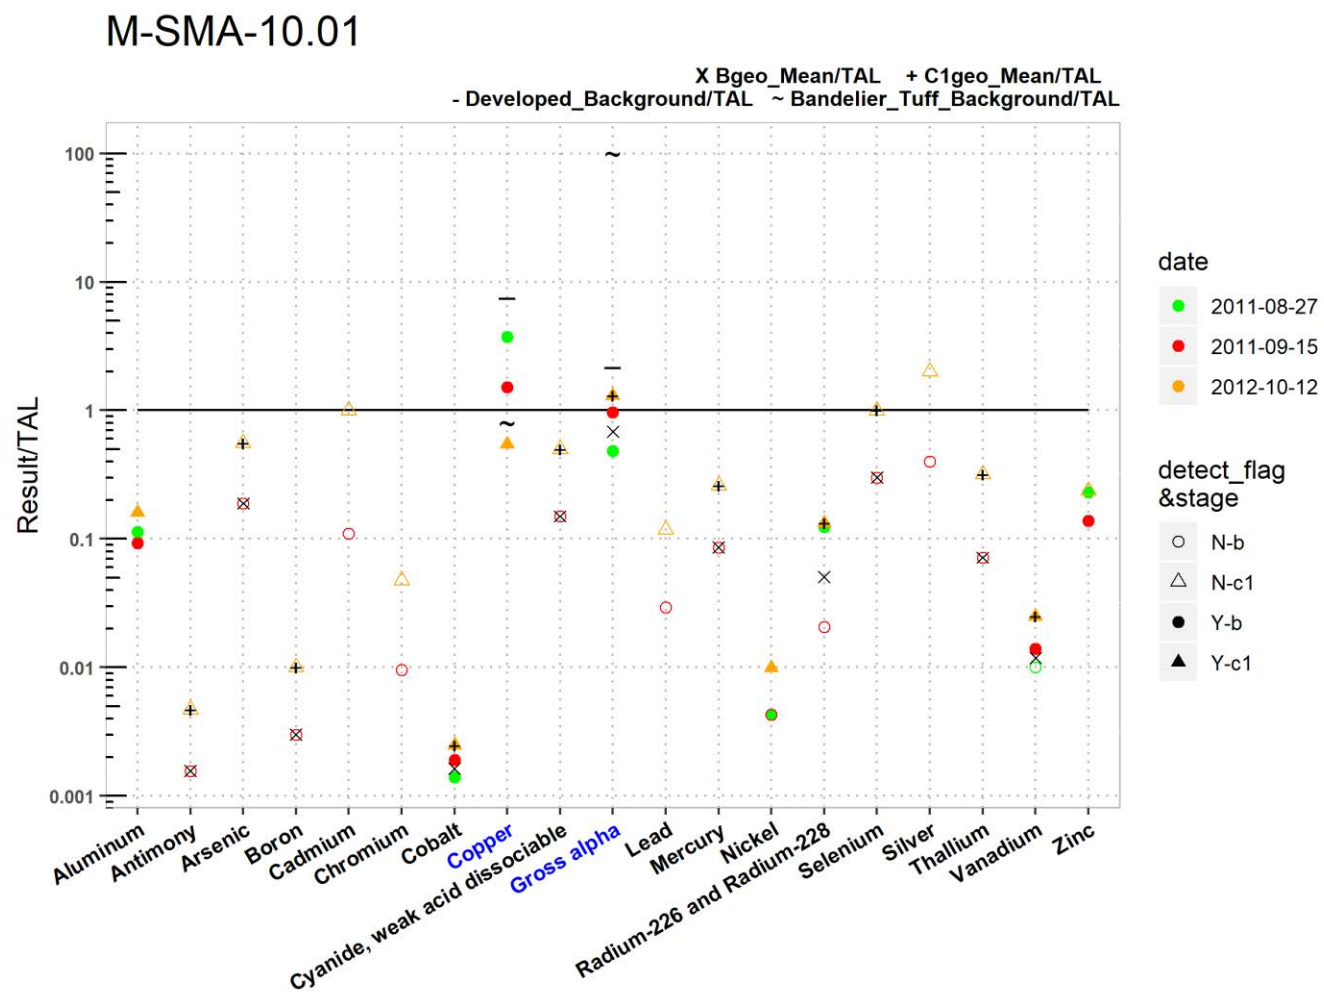
Figure 108-2 Analytical results summary for M-SMA-10.01

TAL exceedances were also evaluated against the appropriate storm water BVs, that is, “Bandelier Tuff background” for undisturbed SMAs or “developed background” for urban settings. BVs are expressed as UTLs using the approved EPA method for calculating BVs. UTLs for undisturbed SMAs were derived from storm water runoff containing entrained sediments derived from Bandelier Tuff and are labeled “Bandelier Tuff Background” in Figure 108-2. UTLs developed for urban settings were derived from runoff from developed landscapes on the Pajarito Plateau, including buildings, parking lots, roads, and associated features, and are labeled “Developed Background” in Figure 108-2.

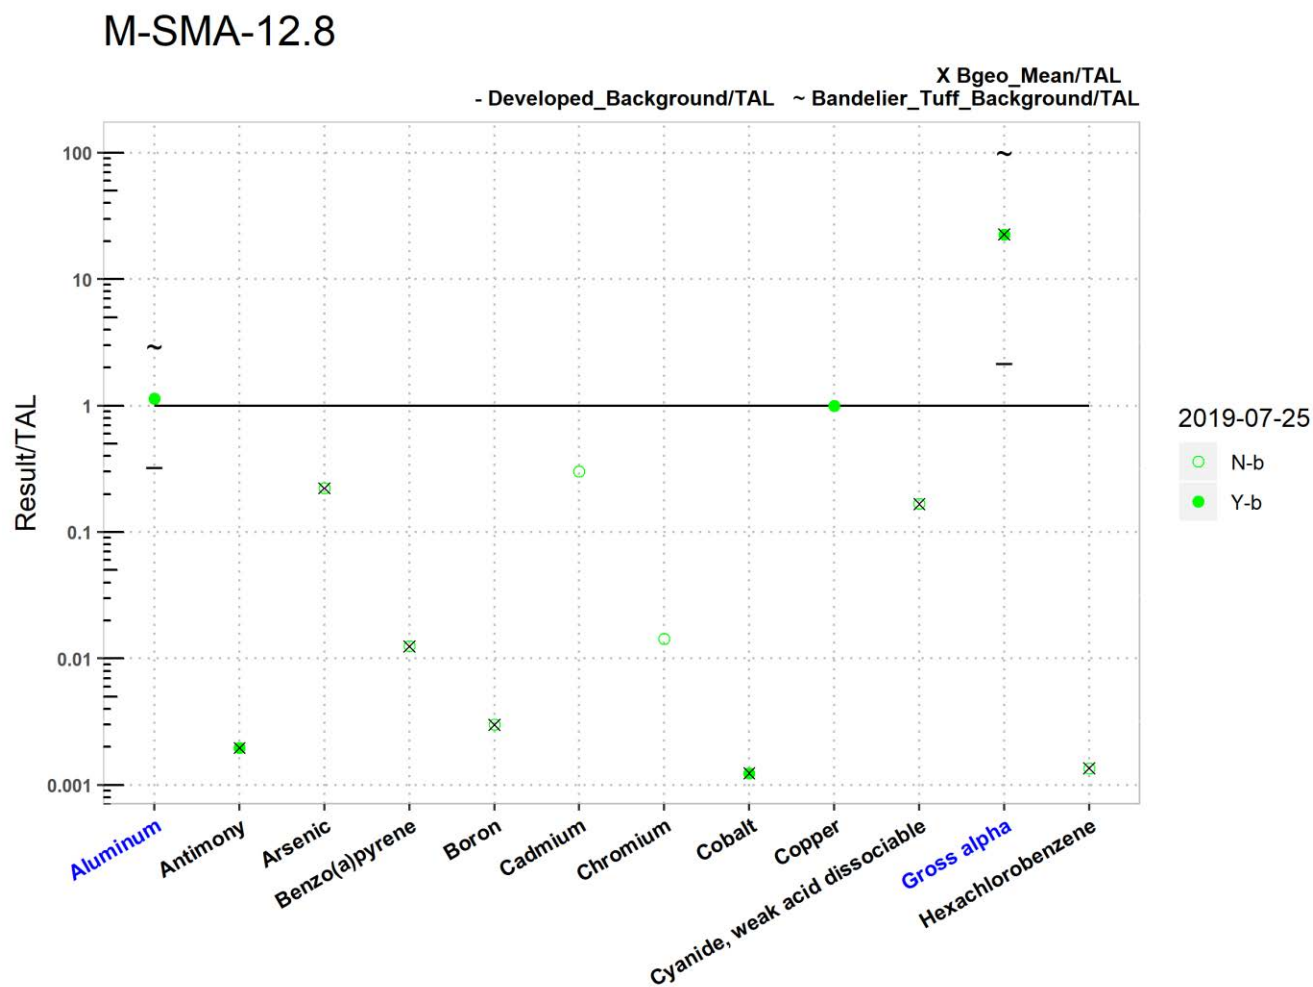
Figure 115-2 Analytical results summary for M-SMA-12.8

SWMUs 05-001(a) and 05-002 were monitored within M-SMA-12.8. As part of extended baseline monitoring, a baseline storm water sample was collected on July 25, 2019 (Figure 115-2) to determine if corrective action was required. In September 2015, NMED issued a COC for SWMUs 05-001(a) and 05-002. These Sites are now certified as corrective action complete, and monitoring of storm water discharges has ceased at M-SMA-12.8. No further sampling is required for M-SMA-12.8 for the remainder of the IP. Analytical results from this sample yielded exceedances for aluminum (849 µg/L), gross-alpha activity (338 pCi/L), and selenium (7.07 µg/L) and are presented in Figure 115-2.

TAL exceedances were also evaluated against the appropriate storm water BVs, that is, “Bandelier Tuff background” for undisturbed SMAs or “developed background” for urban settings. BVs are expressed as UTLs using the approved EPA method for calculating BVs. UTLs for undisturbed SMAs were derived from storm water runoff containing entrained sediments derived from Bandelier Tuff and are labeled “Bandelier Tuff Background” in Figure 115-2. UTLs developed for urban settings were derived from runoff from developed landscapes on the Pajarito Plateau, including buildings, parking lots, roads, and associated features, and are labeled “Developed Background” in Figure 115-2.
